CROOKED RIVER

WATERSHED SURVEY

Cumberland County Soil & Water Conservation District

March 2012

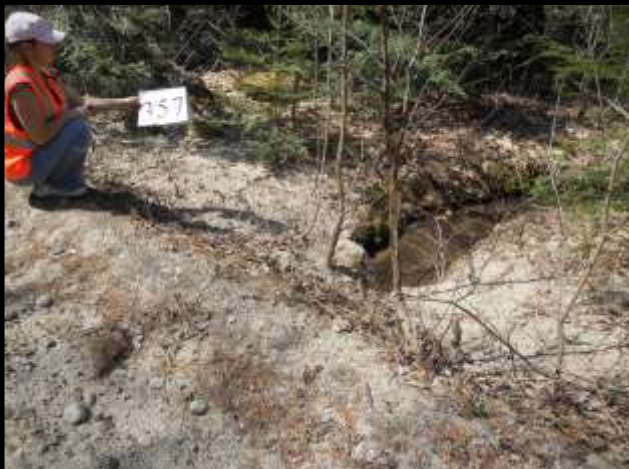
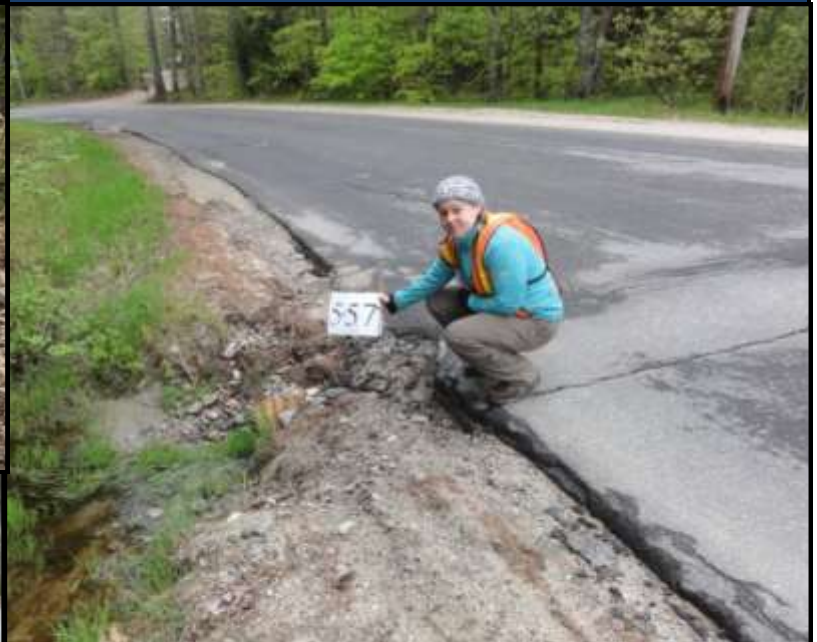
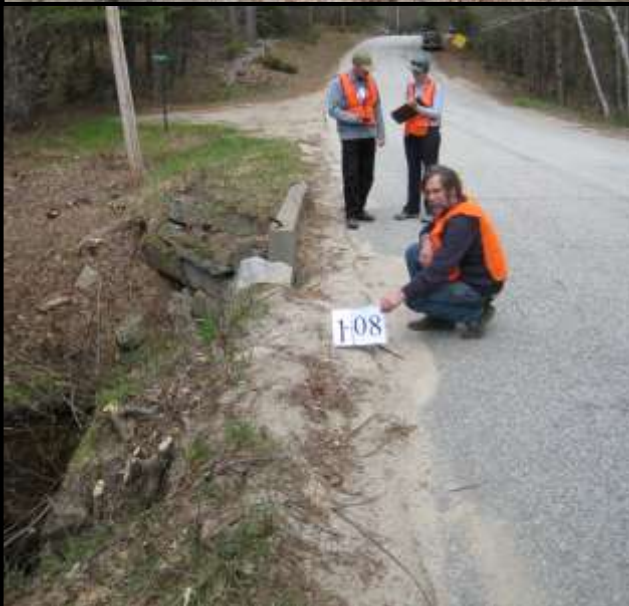
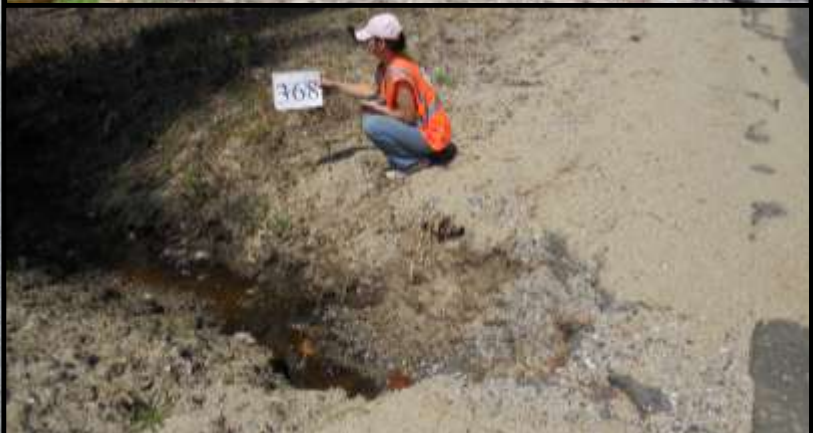
- ◇ Unstable culvert inlets/outlets
- ◇ Road shoulder erosion
- ◇ Unstable ditching/erosion
- ◇ Clogged or rusted culverts
- ◇ Road surface erosion
- ◇ Buildup of winter sand
- ◇ Undersized culverts

- ◇ Clean out culverts and armor inlets/outlets with rip rap
- ◇ Re-grade, vegetate to stabilize shoulders
- ◇ Clean, re-shape and stabilize ditches
- ◇ Clean out and/or replace
- ◇ Grade, shape and stabilize surface with quality material
- ◇ Remove winter sand build up
- ◇ Replace with larger size culvert and stabilize
