Crooked River Riparian Corridor Inventory

Introduction

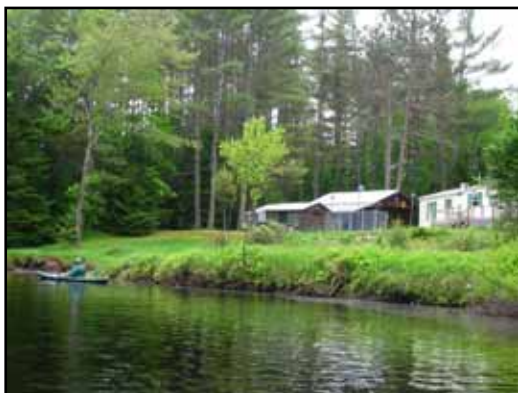
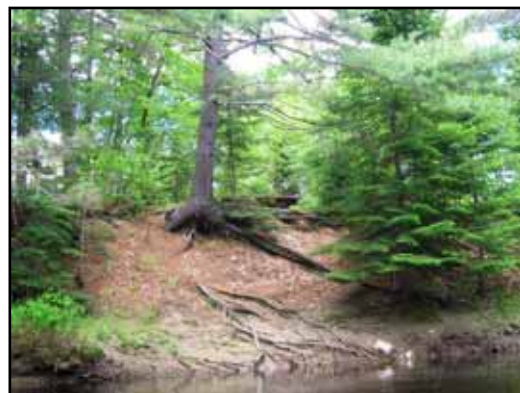
Sector 1: Common Issues

Issues: There is a great deal of natural bank erosion evident and some bank erosion at river access points. *Common problems:* Residential river access on steep sandy banks, residential lawns, some trash noted, ATV traffic crossing through shallow areas of a river tributary at powerlines which run adjacent to the river.

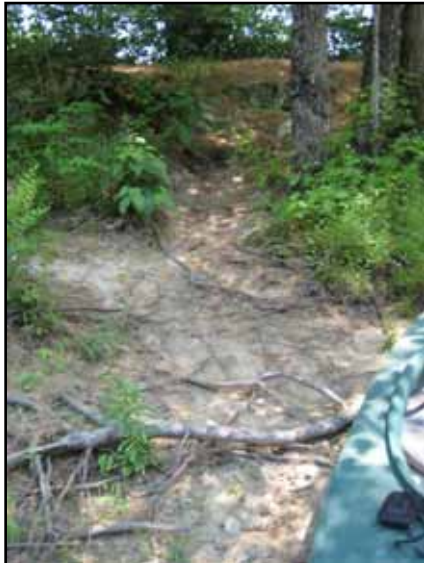
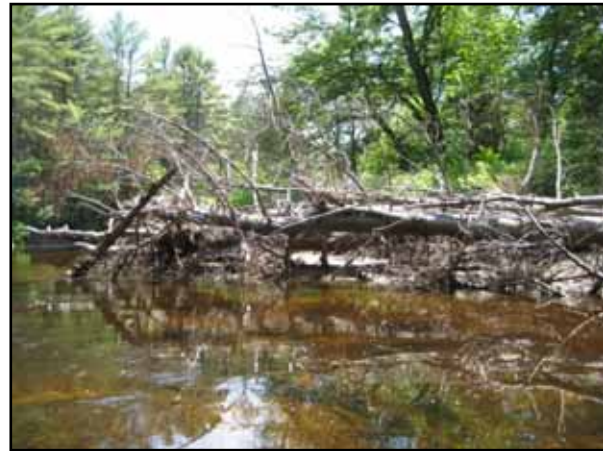
Sector 2: Common Issues

Issues: Natural bank erosion on the outsides of meanders, fallen trees from natural undercutting, small amounts of residential waste, and some light erosion at beginning and end access points caused by anglers and kayakers.

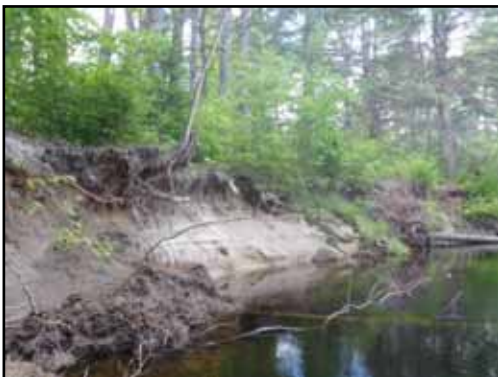
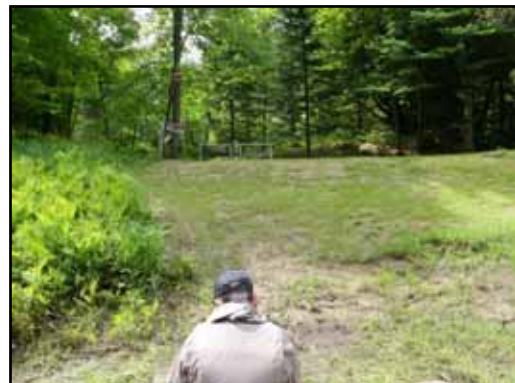
Section 6: Common Problems

Issues: Most issues were due to naturally occurring erosion due to natural geomorphology of the river such as bank failures, undercutting, and fallen trees. River banks are very unstable due to sandy composition. One seasonal camp was observed where vegetation had been cleared from the banks.

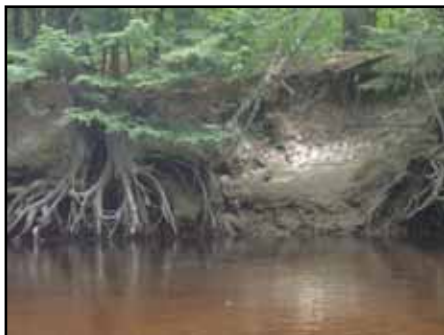
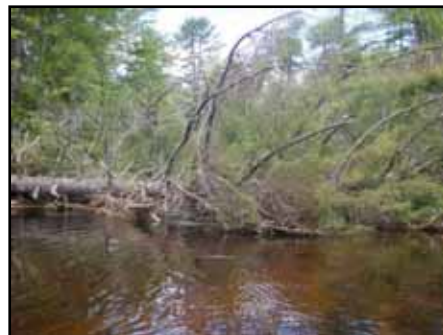
Issues: Most impacting issues were of natural cause, primarily trees and woody debris in the river which had either blown down or fallen in due to natural undercutting of the embankment. At numerous places the river was blocked for floating and had to be portaged. Some trash was noted (a barrel) though not a great amount.

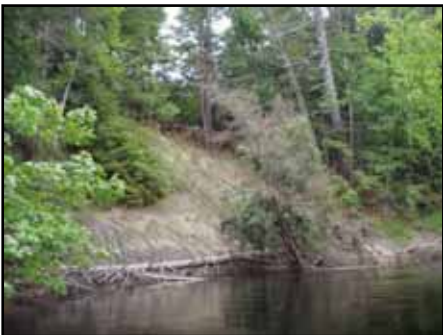
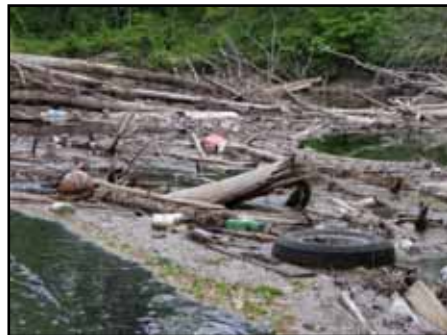
Section 8: Common Problems

Issues: Natural bank slumping and erosion. Trash and old tires in the river caught in downed trees.

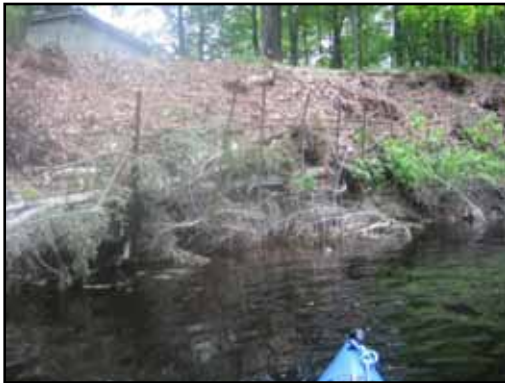
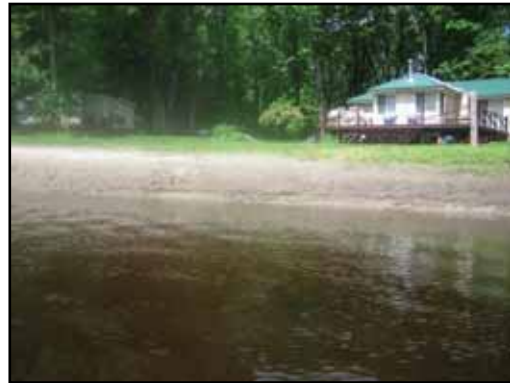
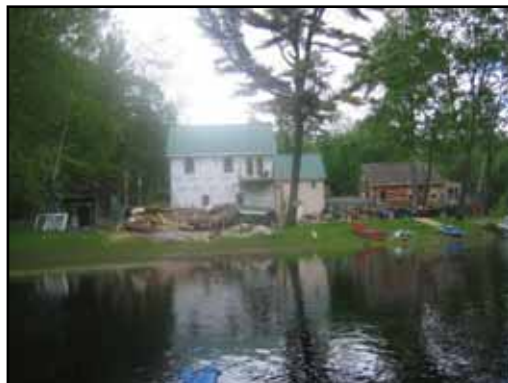
Sector 9: Issues

Issues: Residential lawns, river access erosion, yard waste dumped on river banks, some demolition debris on banks. (Note: Some of the volunteer's data sheets were lost when their canoe tipped over therefore no "Problem Site Data Sheets" were recorded but their photographic log shows these issues were observed.)
