Woods Pond

Watershed Protection Project, Phase I

FINAL PROJECT BROCHURE

2014 - 2016

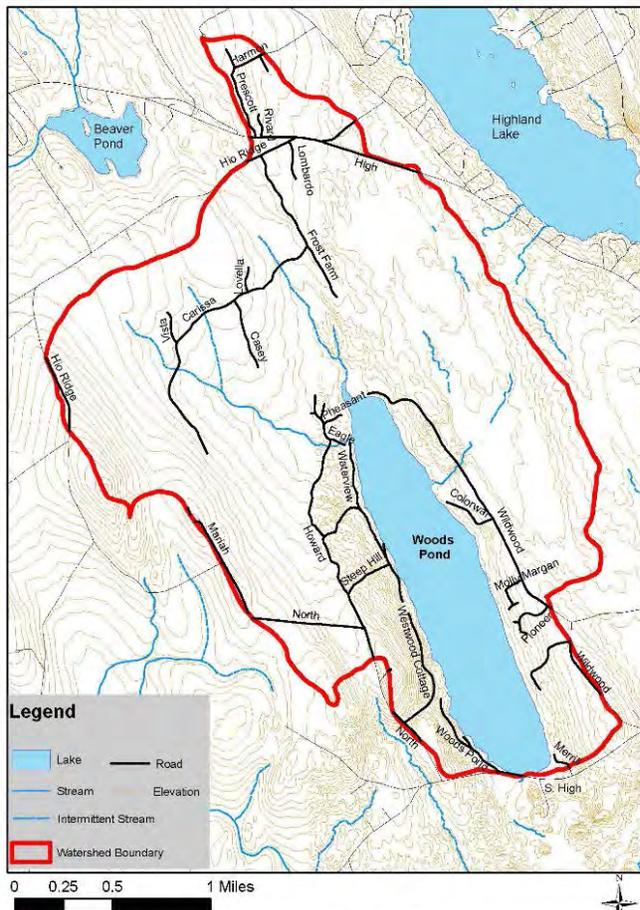
Map created by S. Pienia, Maine DEP

Woods Pond Watershed – The red line shows the Woods Pond watershed, or the area of land that drains water into the lake. Activities on the land within this boundary can impact the health of the lake.

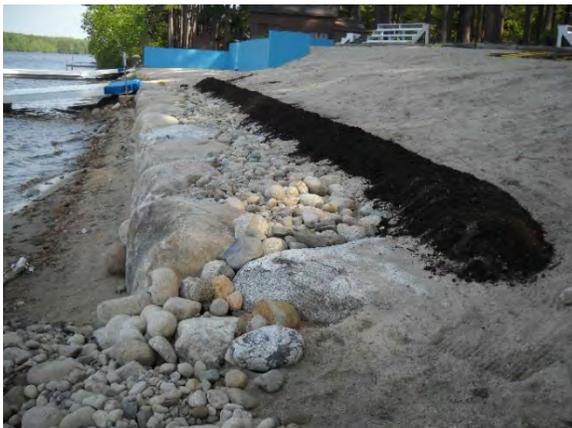
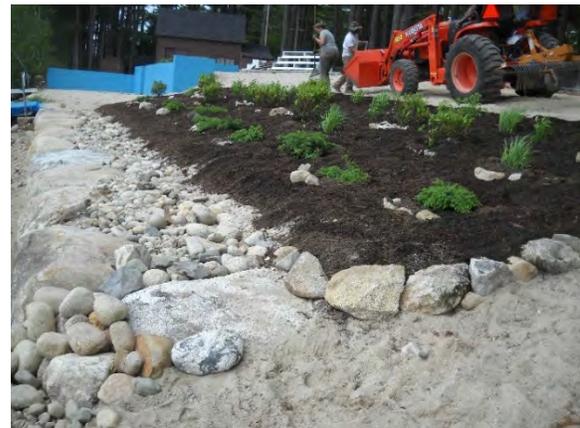
Stable Shoreline – Boulders and plants were used at this site to hold soil in place to prevent it from washing into the lake.

In the example shown below, erosion was documented in the 2012 watershed survey at this summer camp site off Wildwood Road. Planting a buffer was an important part of the erosion control plan for the site. First, the steepness of the beach was reduced with the installation of boulders above the high water line. A buffer was then planted to trap erosion caused by runoff and foot traffic. Plants used included Bayberry, Oxeye Daisy, Hyssop Skullcap, Blackeyed Susan, Switchgrass and Common Juniper. Special planting techniques were used because beach sand cannot support plant growth. Over time, the plants will fill in to create a vegetative “wall” that cuts erosion, enhances scenic beauty, overspreads the shoreline boulders, and attracts wildlife. The grant paid for half of the cost of the buffer planting, and the camp owner paid for the other half.

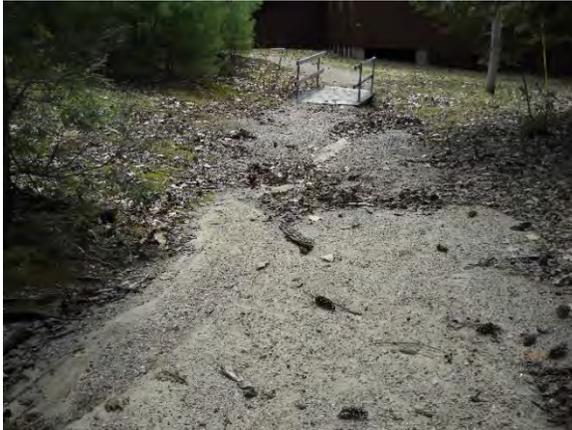
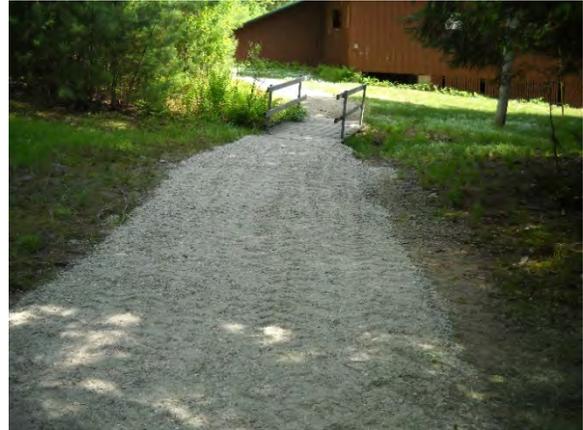
KINGSWOOD CAMP

Path to Clean Water – The grant worked with Kingswood Camp to improve a path that was contributing sediment to a stream and Woods Pond.

A brook runs through the heart of the camp. There is a heavily-used footpath leading to a small bridge that crosses the brook. Over the years, foot traffic had created a significant erosion issue. Sediment from the path washed into the brook and into Woods Pond. A large sediment delta in the brook shows how much material washed off the trail.

The camp worked with the grant to share the costs of an erosion control project to improve the trail. The solution included sloping the footpath toward a wooded buffer and away from the brook. The path was re-surfaced with $\frac{3}{4}$ -inch gravel, which is less likely to erode. Two turnouts were built across the footpath as an added measure to direct runoff away from the brook and into the buffer. Finally, bare areas were seeded and mulched.

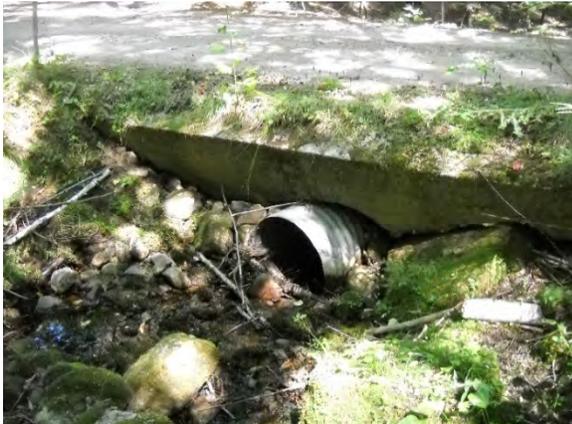
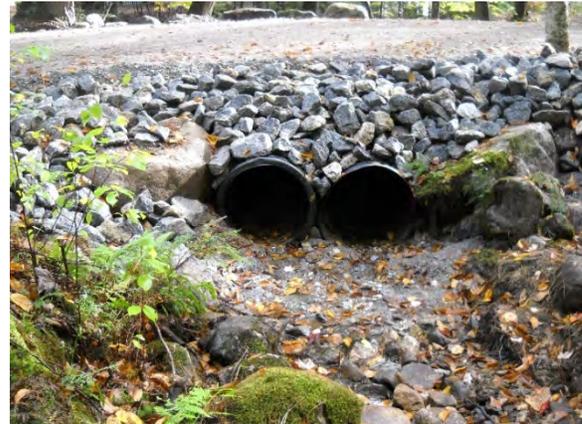
WATERVIEW TRAIL

Improved Flow – One undersized culvert was replaced by two larger culverts at this site on Waterview Trail. The new culverts allow more water to flow through the pipes during storms to reduce erosion impacting Woods Pond.

Waterview Trail is a gravel road that is heavily used during the summer. It is at the base of very steep terrain on the west side of Woods Pond; consequently, the steep brooks that spill off this side of the watershed flow very rapidly into the pond. One such brook crossing just north of the junction of Steep Hill and Waterview Trails had an undersized culvert. As a result, water would back up and occasionally overtop the road during intense storms, creating massive erosion that washed into Woods Pond. The culvert itself was rusty and failing. In addition, the culvert was too short to stabilize its inlet and outlet with angular stone rip-rap, an important measure to reduce erosion.

The photographs above show the inlet before and after construction. A major source of erosion was eliminated. There are similar undersized culvert crossings throughout the Woods Pond watershed with erosion problems similar to this one. The *Woods Pond Watershed Protection Project, Phase I*, fixed many, but not all, of them. It is hoped that this work will demonstrate how to fix the rest.

The solution included removing a collapsing stone buttress that sat above the culvert. The old, rusty and undersized culvert was removed and replaced with two new plastic culverts. Each of the new culverts measure 24 inches in diameter, which increases the capacity to pass flows during storms. The new culverts measure up to 10 feet longer than the original 20-footer, allowing the contractor to armor the inlets and outlets with rip-rap.

In addition, a sediment pool was created on the south side of the brook to capture runoff from Steep Hill Trail before it entered the brook and flowed to Woods Pond.

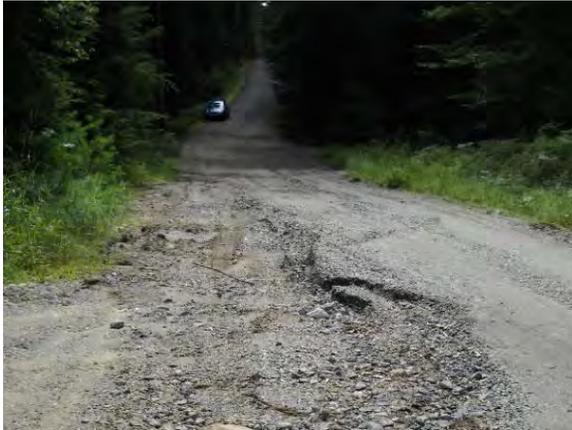
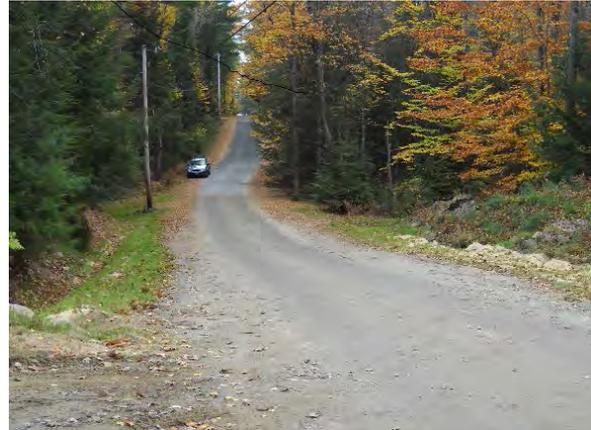
WILDWOOD ROAD

Collaborating for Clean Water – The Wildwood Road Association and Town of Bridgton worked with the grant to address drainage challenges to reduce sediment washing into Woods Pond.

Wildwood Road at the Sucker Brook crossing was the most severe erosion problem documented in the Woods Pond Watershed Survey. Here, the road makes a sharp dip down to the brook from both the north and south approaches. This site was unique because the paved, south approach is managed by the Town of Bridgton, while the gravel, north approach is a private road maintained by the Wildwood Road Association. This section highlights improvements that were made on the private portion of the road.

The gravel road was poorly shaped; it was “bowl” shaped rather than crowned, or raised, in the middle, which resulted in runoff being unable to flow into the ditches on either side of the road. Instead, water ran down the road and washed sediment into the brook, which flows a short distance to Woods Pond. The ditches themselves were poorly shaped and filled so that if runoff had made it to them it is doubtful they could have handled the load. To its credit, the road association had created a turnout at the lower end of the ditch on the west side of the road; however, this turnout had filled over time.

An engineer (paid for by the grant) designed the solution for this complicated site, which included adding material to the road and properly crowning it in the middle, which allows runoff to flow to the sides rather than running down the middle of the road. The berms on the road shoulders were removed. The ditches were re-shaped and deepened. The bottom of the west ditch was lined with erosion control matting and seeded. The turnout was enlarged and angular rocks were added at its outlet. A damaged culvert at the location of the town snowplow turnaround (which is on the private road) was replaced and properly armored. In addition, a sediment pool was created at the outlet of the ditch on the east side of the road.

The Town of Bridgton did its part to deal with this serious erosion problem. Their work included reshaping and repaving the town portion of the road, and installing rock-lined ditches and turnouts. This site is an excellent example of how collaboration can solve clean water challenges!

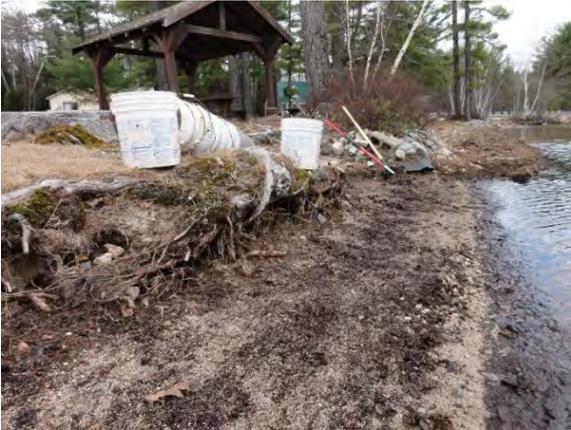
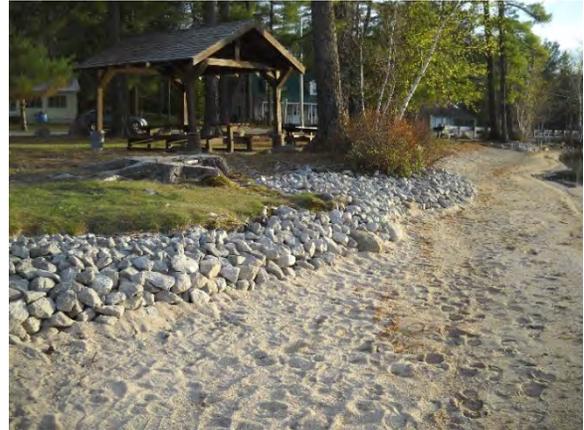
WOODS POND TOWN BEACH

Beach Cleanup – Improvements at the Woods Pond town beach include placing fabric and stone in undercut areas to hold soil in place.

The beach is on the receiving end of the prevailing northwesterly winds that roll down the lake, generating huge waves. Consequently, wave action led to severe undercutting of the bank, which was documented in the 2012 watershed survey and worsened in the years before the start of the *Woods Pond Watershed Improvement Project, Phase I*. In addition, heavy foot traffic from the picnic area down to the beach had created surface erosion as evidenced by exposed roots.

Working with the Town of Bridgton and the Woods Pond Water Quality Association, erosion control measures were recommended and implemented through the grant. The solution included filling the undercut bank with geotextile fabric and crushed stone, then armoring it with angular rock rip-rap. Materials were provided by the town. Members of the Woods Pond Water Quality Association provided the muscle to put the fabric and rocks in place.

The result of this collaboration was a successful erosion control project in a highly visible area. The initial work took place in 2014, and a buffer planting the following year (also through the grant) will further stabilize and beautify the beach!

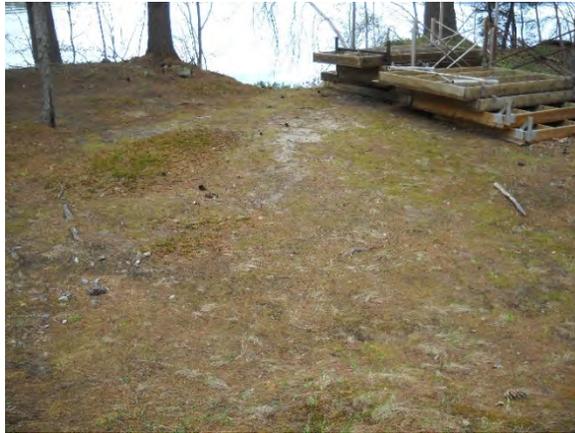
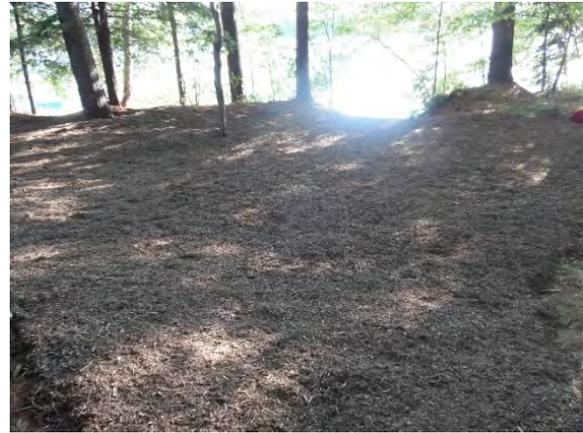
Runoff at this property carried soil into Woods Pond at the landowner’s canoe/kayak put-in. Vegetation, such as grass and shrubs couldn’t gain a foothold in this shady, high-foot-traffic area. The solution was simple: cover the bare soil with erosion control mulch, which is heavier and stays in place better than traditional mulch. Now, runoff will be trapped and absorbed in the mulch before it washes into Woods Pond.

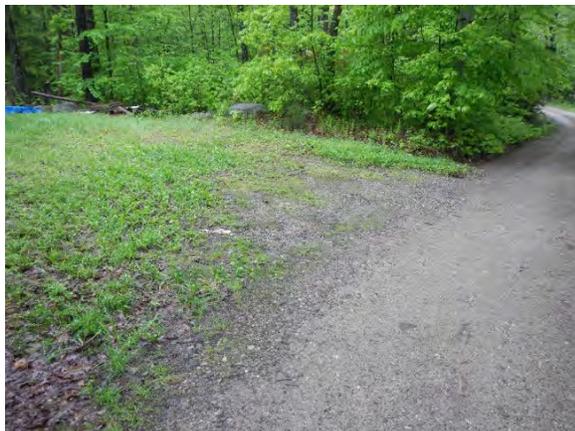
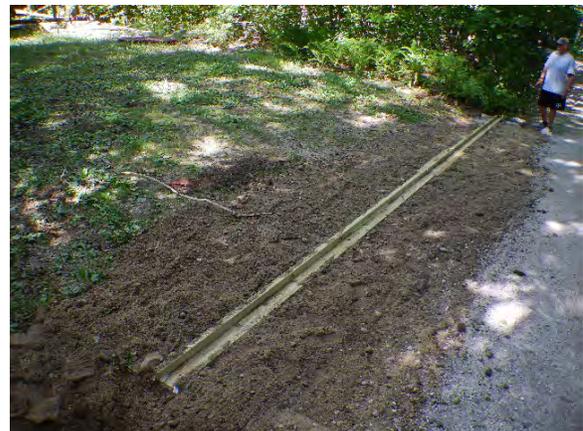
At this site, runoff carried eroded material down a driveway and spilled out on to Waterview Trail, a gravel road. Runoff then flowed downhill – picking up more soil and sediment on the way – and dumped into a brook, which flowed a short distance to Woods Pond. The owner installed an open-top culvert across the driveway. Now, runoff from the driveway will drop into the open-top culvert and flow to the road ditch, instead of on to the road itself.
