CROOKED RIVER

WATERSHED SURVEY

Cumberland County Soil & Water Conservation District

March 2012

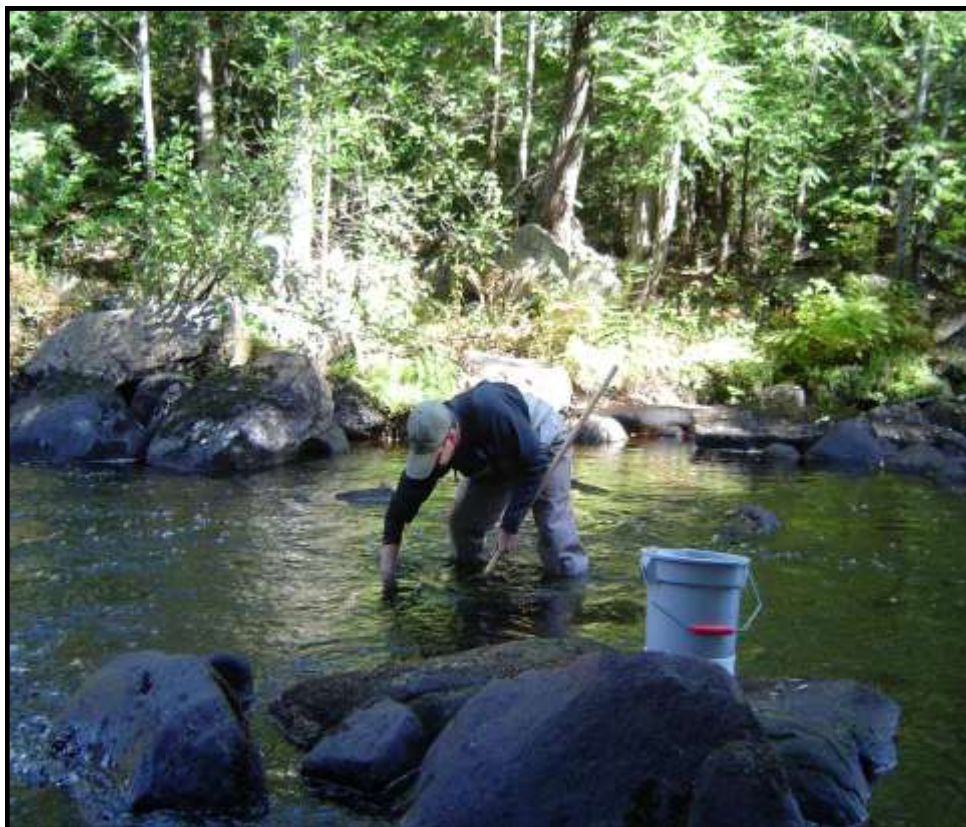
Nate Whalen, from Portland Water District retrieving a rock bag. These are placed and left in the river for four weeks. When retrieved, macroinvertebrates types and numbers are documented.

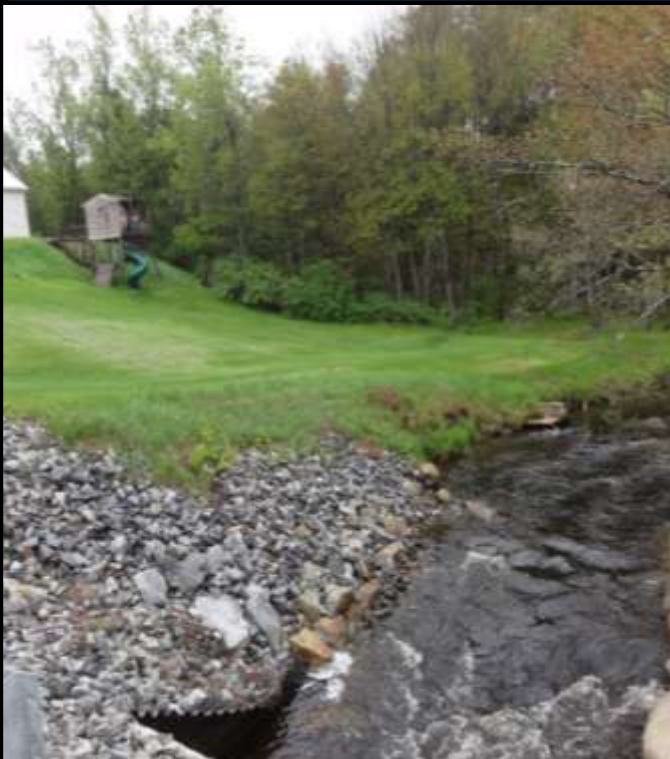
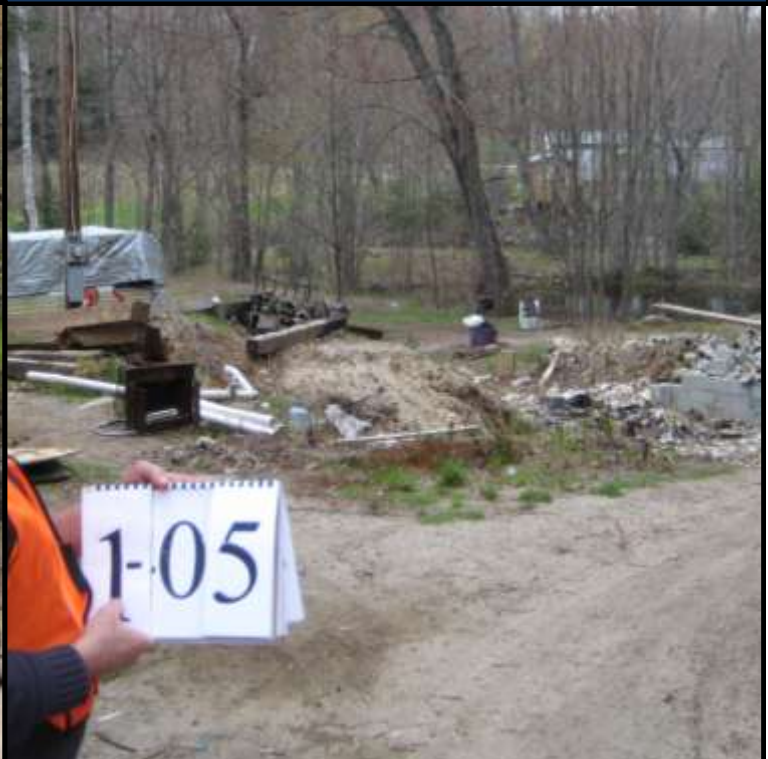
Residential areas were associated with 11% of the identified sources of polluted runoff to the Crooked River. These problems pose a significant threat to water quality and fortunately, most sites can be corrected with easy, and low to moderate cost fixes.

- ◇ Seed and mulch bare soil
- ◇ Establish or enhance vegetated buffer
- ◇ Limit foot traffic-define paths and stabilize
- ◇ Install drip line trench to catch roof runoff
- ◇ Install water diverters
- ◇ Remove trash

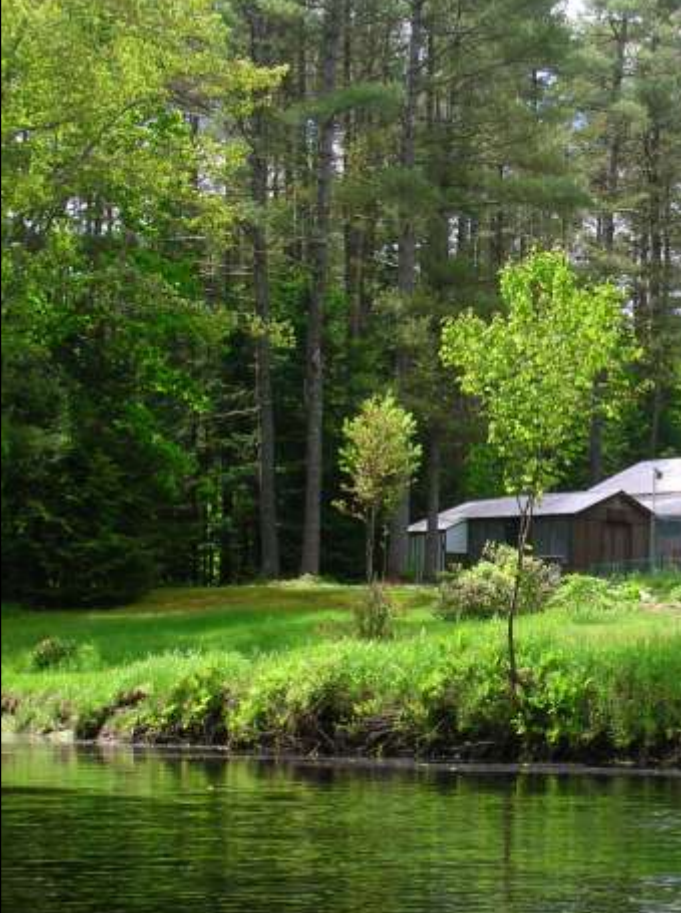
Lack of Buffers - Buffers help keep polluted runoff from entering the river and the varied root systems keep soils in place. Groundcover plants and the duff layer (leaves, pine needles, etc.) help slow runoff, trap sediments and recycle nutrients.

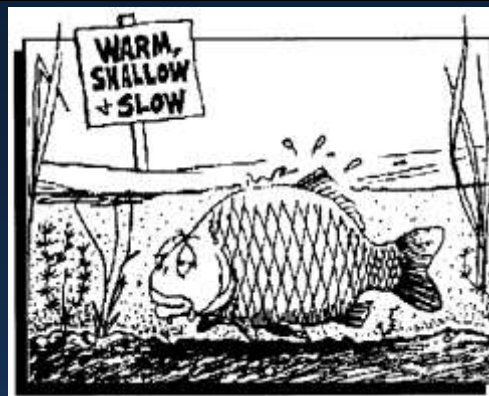
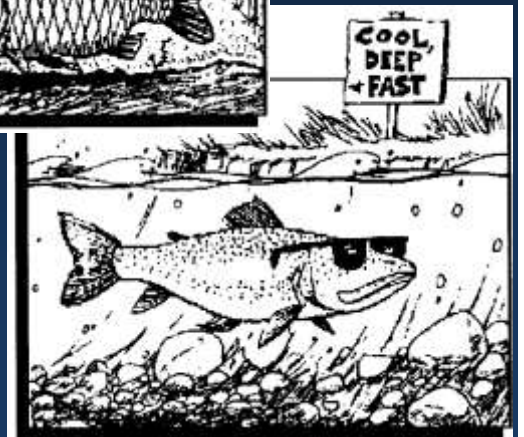
Sediments: Excess sediments (soil erosion) cause the water to become cloudy making it difficult for fish to see and feed properly. Sediments can also damage fish gills and impair the feeding and breathing processes in aquatic insects or fish food. Sediment deposits cause streams and rivers to become shallower and wider - increasing flooding problems. Shallow water is also heated by the sun which causes temperatures to rise and in time cold water fish like trout will die off.
