Crooked River Riparian Corridor Inventory

Introduction

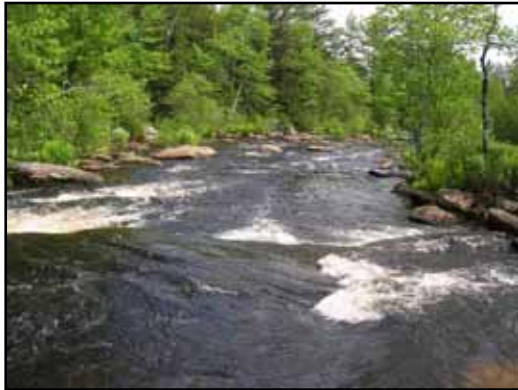
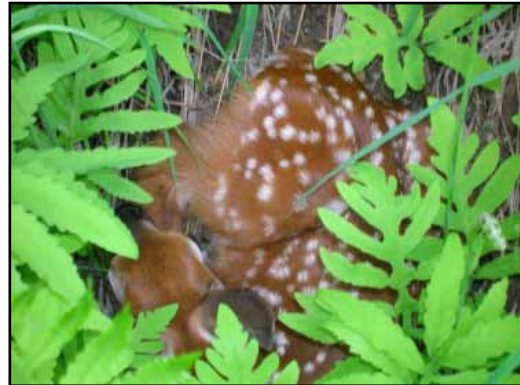
beyond the residential area, access to the river by land is very limited. The riparian area is relatively undisturbed except for a few places where ATV traffic was very evident and actually impacted the river banks as well as shallow areas of the river where they crossed. The surveyors noted beaver activity along this stretch and deer were seen including a tiny fawn.

Issues: There is a great deal of natural bank erosion evident and some bank erosion at river access points. *Common problems:* Residential river access on steep sandy banks, residential lawns, some trash noted, ATV traffic crossing through shallow areas of a river tributary at powerlines which run adjacent to the river.

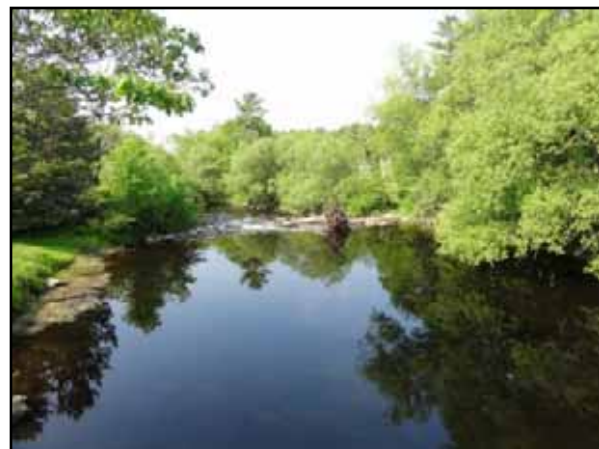
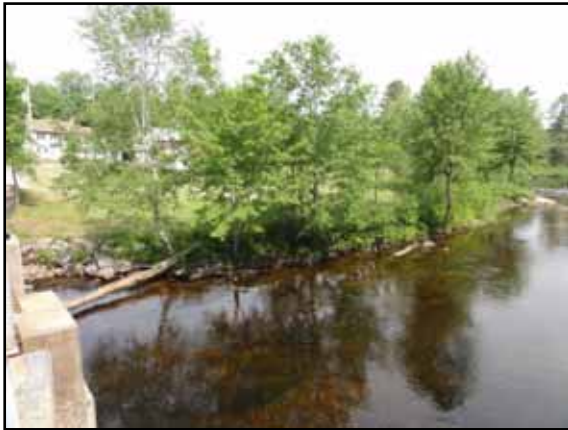
Sector 4: River Views

Issues: No riparian issues observed

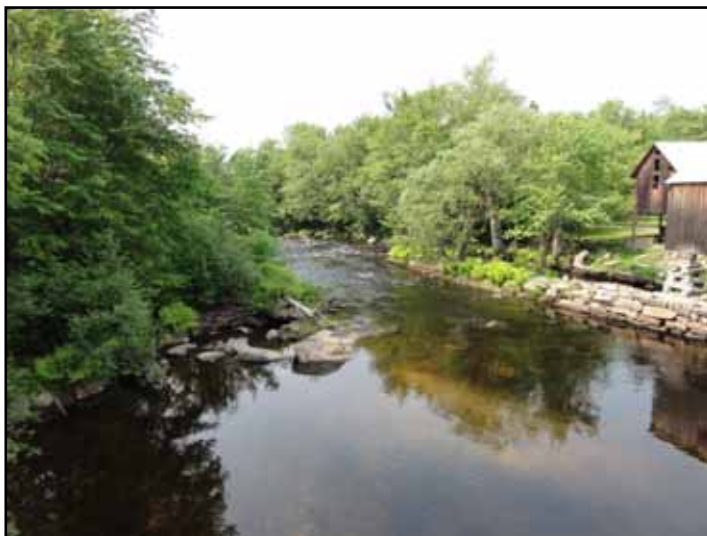
Sector 5: River View at Scribner's Mill Bridge

Issues: Unknown, none presumed.

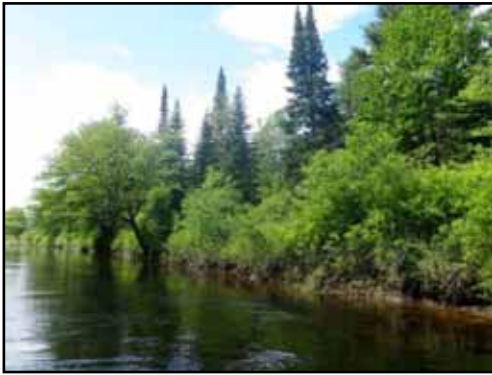
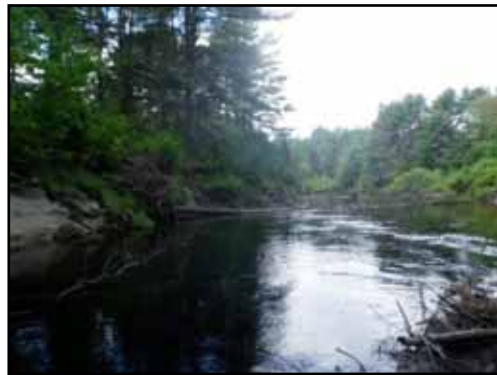
Section 6: River views

Issues: Most issues were due to naturally occurring erosion due to natural geomorphology of the river such as bank failures, undercutting, and fallen trees. River banks are very unstable due to sandy composition. One seasonal camp was observed where vegetation had been cleared from the banks.

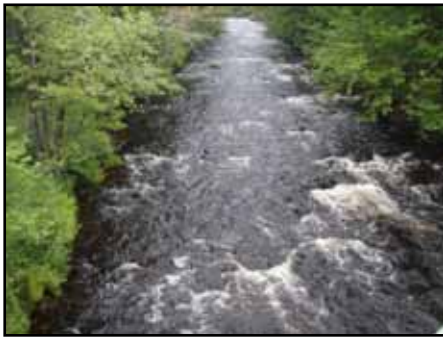
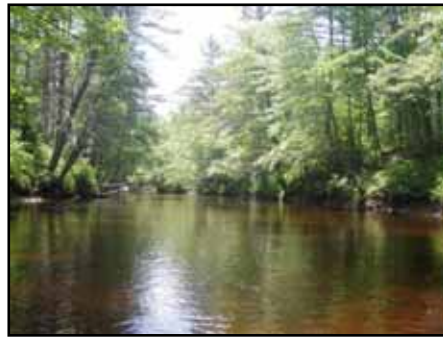
Section 7: River Views

From the Notes of Volunteers Joe Loughran and Gail Miller: This is a beautiful stretch of river with very little human impact. It is surrounded by forest. The river is generally about 75 feet wide with steep banks 10-15 feet high. There is significant natural erosion along the bankings. We did not see any public access to the river. There were two areas of private campgrounds, but they did not seem to impact the river at all. We did note a few camps as we approached the Rte 302 bridge.

There were four major blockages of the river by blow downs. Portaging around these was a challenge. Going up the steep banks and trekking through the woods and re-entering the stream on the other side was hard work. The water was very clean with a beautiful sand bottom. We saw very little debris in the water, natural or human. This is a perfect fishing and canoeing river if the blockages can be opened up and public access provided.

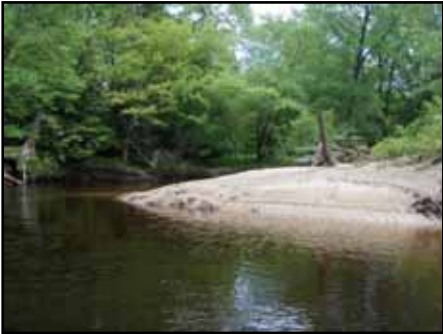
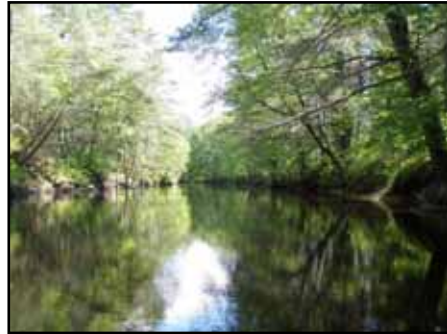
*Section 8:
River Views*

Issues: Natural bank slumping and erosion. Trash and old tires in the river caught in downed trees.

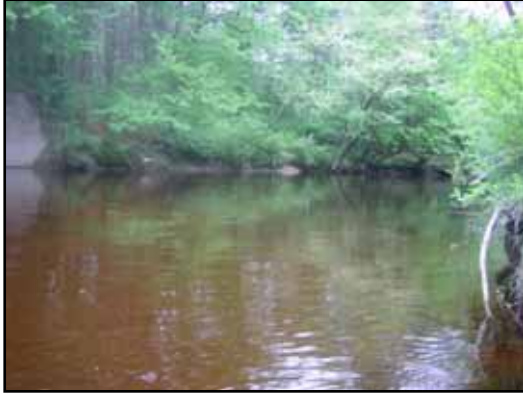
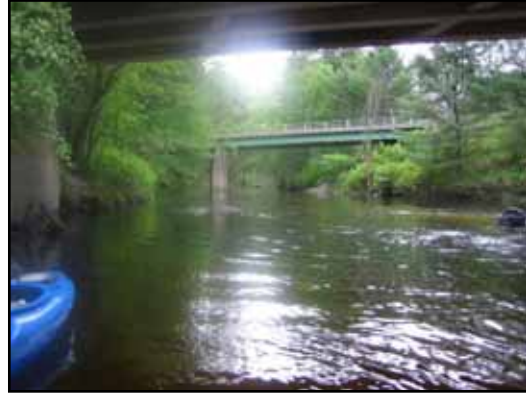
Sector 9: River Views

Issues: Residential lawns, river access erosion, yard waste dumped on river banks, some demolition debris on banks. (Note: Some of the volunteer's data sheets were lost when their canoe tipped over therefore no "Problem Site Data Sheets" were recorded but their photographic log shows these issues were observed.)

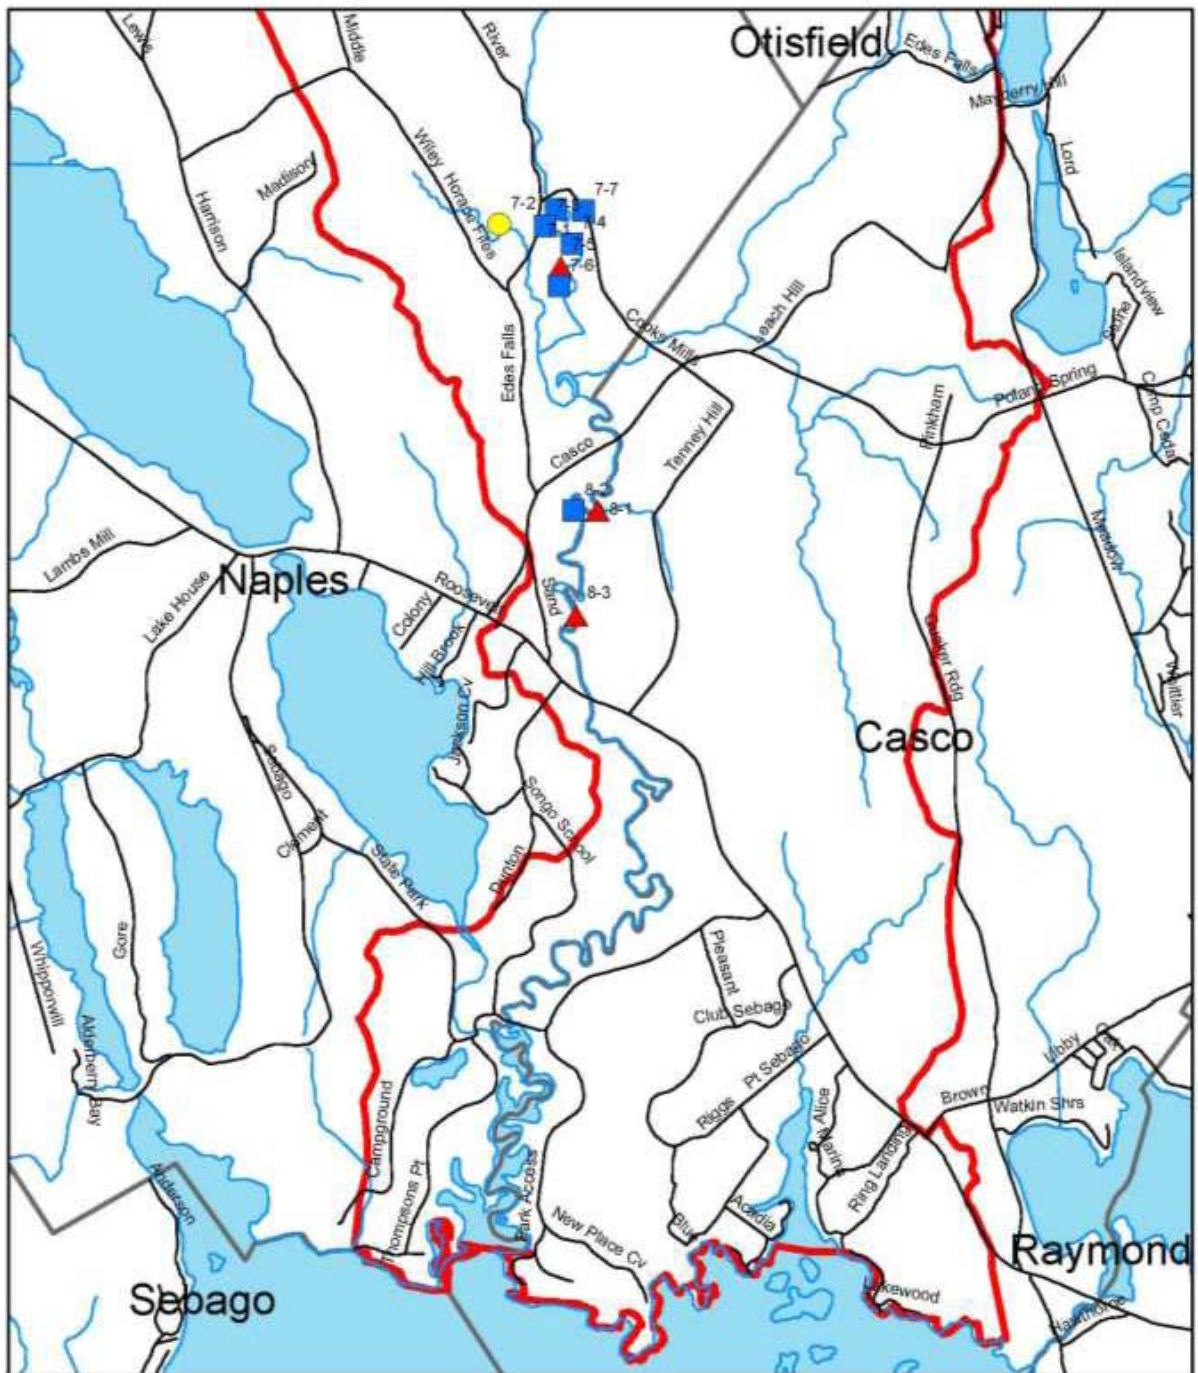
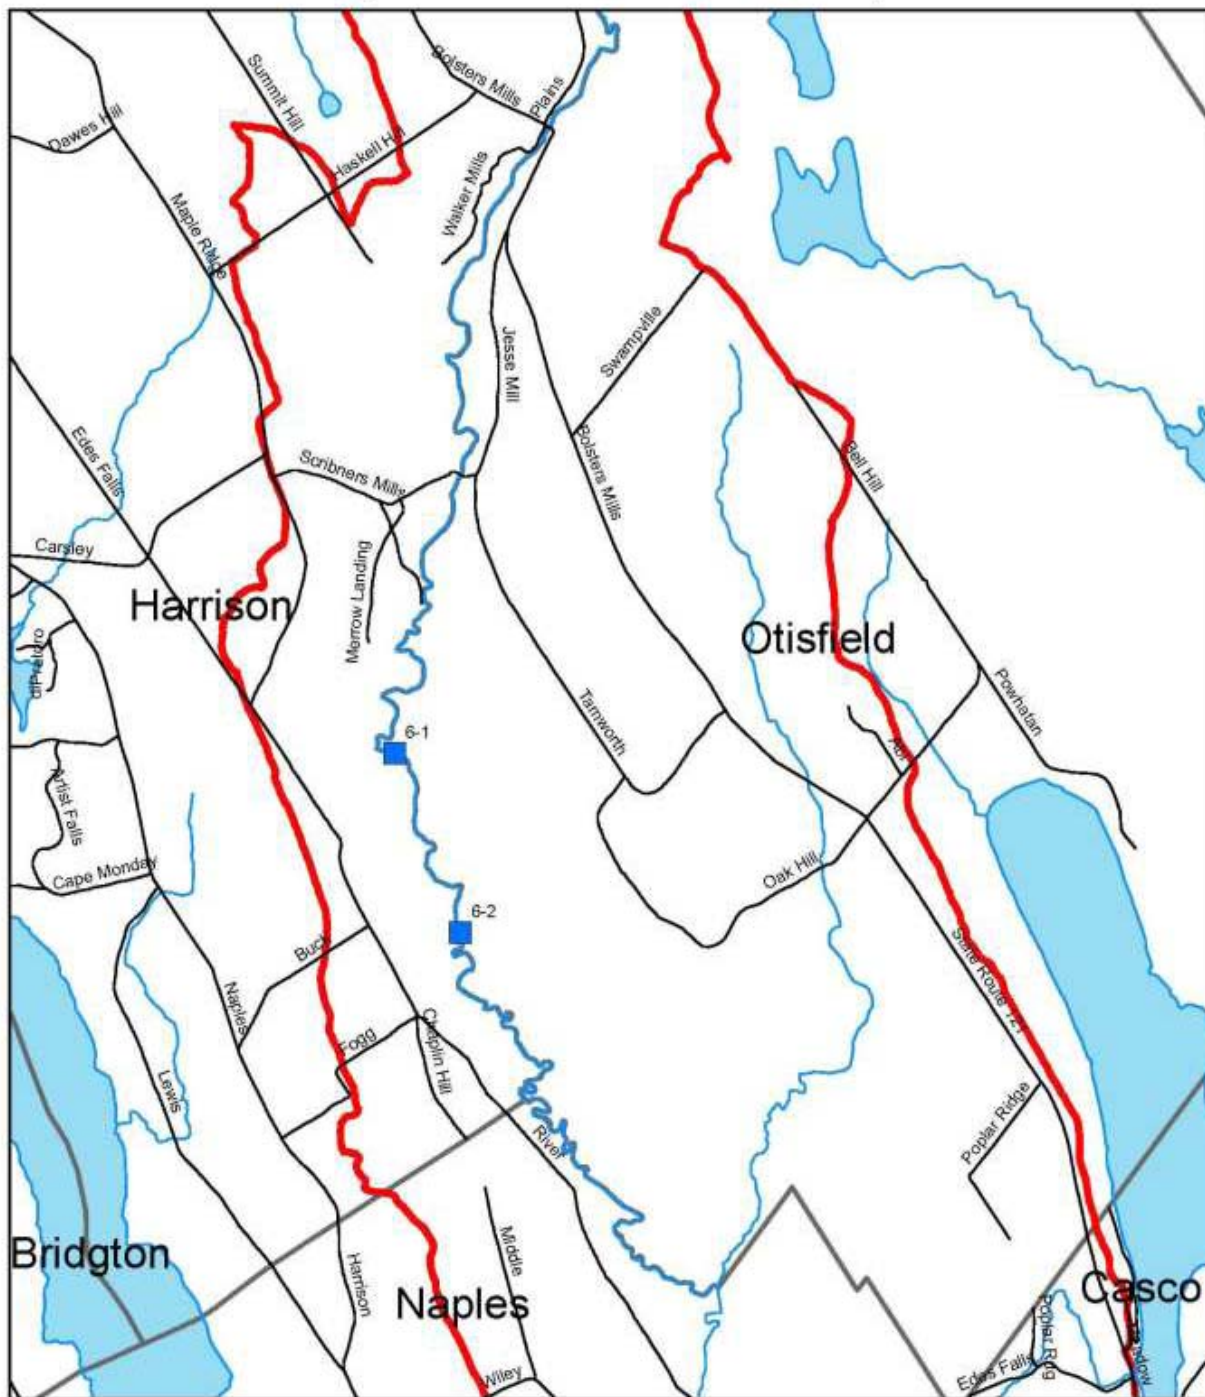
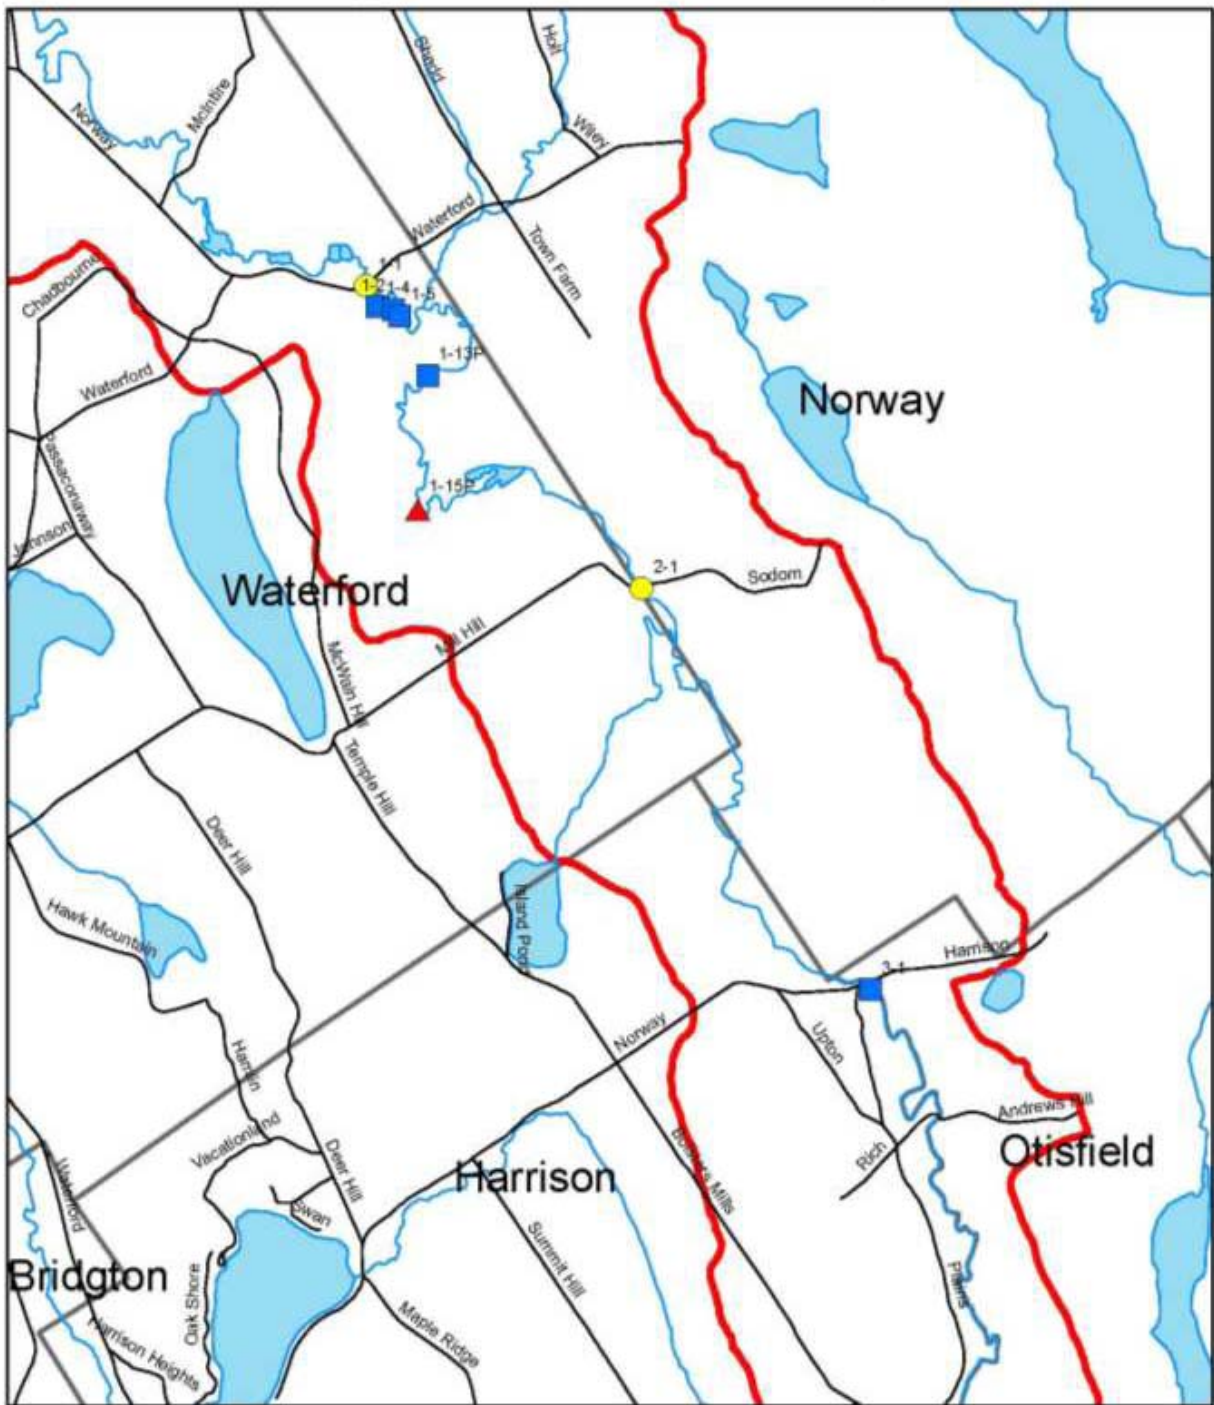
Appendix C:
Problem Site Maps

7	5	75	200	0-10'	n/a	25-50%	Natural, Sand bank, were told there is a gravel pit above this	forest land	immediate shore cleared of vegetation/no regrowth/exposed soils, Bank failure or slumping	n/a	High
7	6	75	50	11-25'	Wild grasses, trees	50-75%	Natural, Blow down blocking river, Portage	forest land	Blow Down	n/a	Med
7	7	75	200	11-25'	Wild grasses, trees	25-50%	Campsite on left bank, major blow down blocking river	forest land, seasonal camp	Campsite, blowdown	Yes	Med
8	1	75	25	11-25'	Wild grasses, trees	50-75%	Natural, Left bank breakdown	forest land	erosion	n/a	High
8	2	50	75	11-25'	Wild grasses, trees	50-75%	Natural, Lots of rubbish in blow downs	forest land	blow downs, trash	n/a	Med
8	3	50	75	26-50'	Trees	50-75%	Multiple blow downs blocking river, difficult portage	forest land	Multiple blow downs blocking river, difficult portage	n/a	High
